# **INDOOR AIR QUALITY ASSESSMENT**

**Lynch Elementary School  
19 Brantwood Road  
Winchester, Massachusetts**

Prepared by:  
Massachusetts Department of Public Health  
Bureau of Environmental Health Assessment  
July, 2000

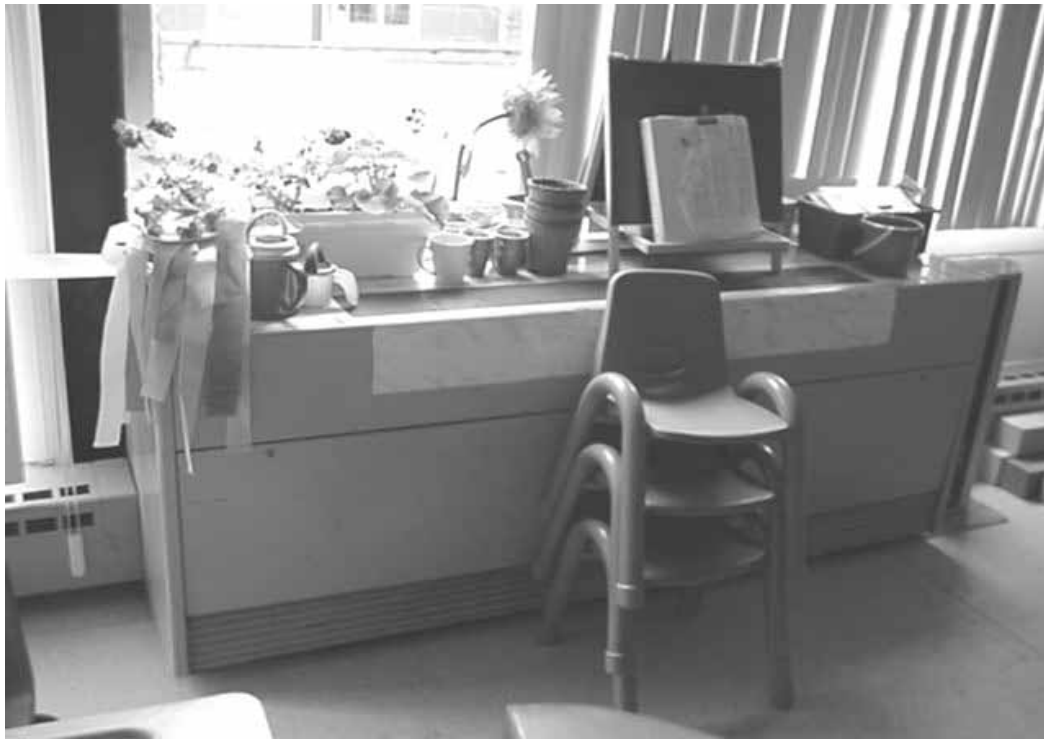
**Picture 1**

Several classrooms contained plants. Plant soil and drip pans can serve as a source of mold growth. Plants were noted on top of univent fresh air diffusers (see Picture 1). Plants should be located away from univents and exhaust ventilation to prevent the aerosolization of dirt, pollen or mold.

**Classroom Univent Note Flowering Plants near Air Diffusers**

10. Move plants away from univents and ensure drip pans are placed underneath plants in classrooms. Examine plants in classrooms for mold growth in water catch basins. Disinfect water catch basins with an appropriate antimicrobial if necessary.

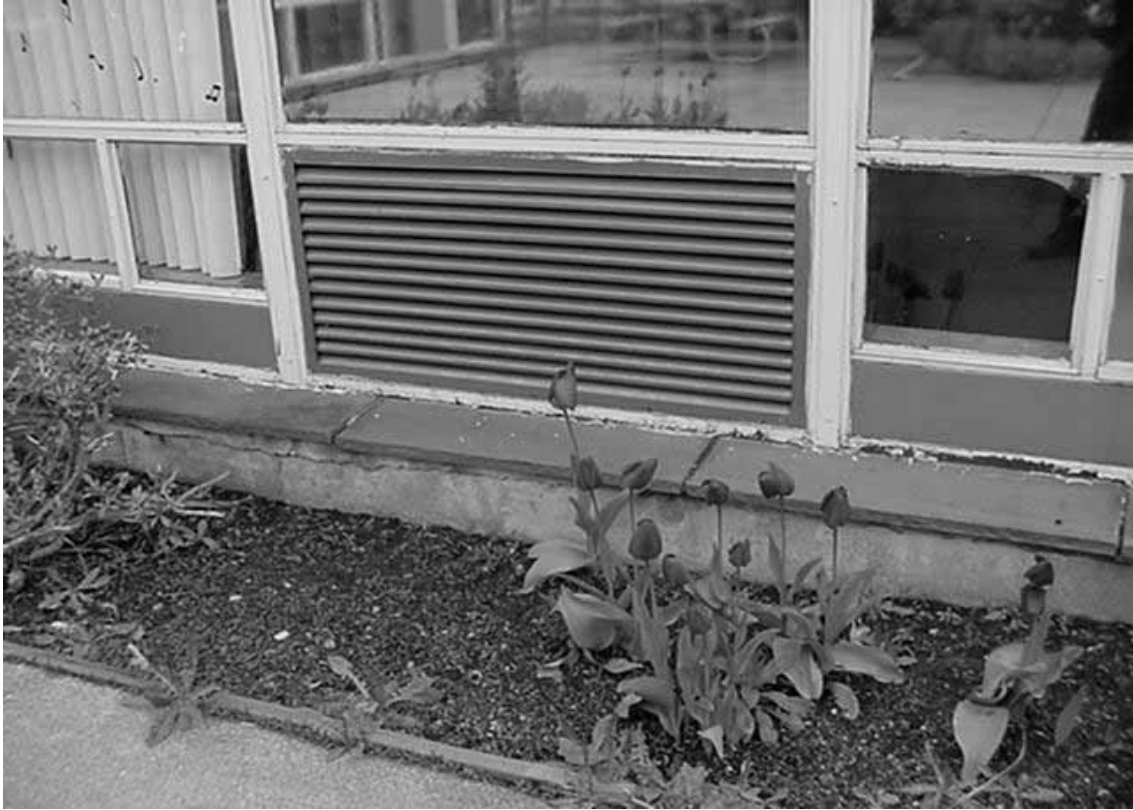
**Picture 2**

**Univent Fresh Air Intake Noted on Exterior Courtyard Wall**

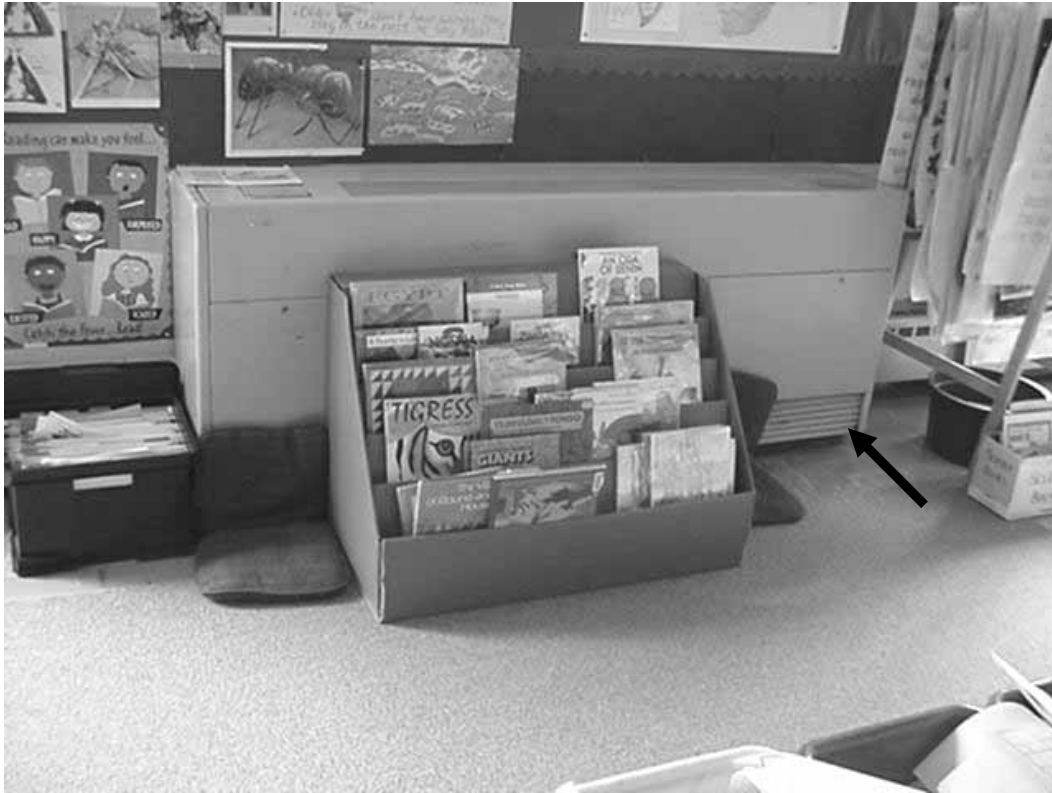
**Picture 3**

**Classroom Univent Note Return Vent is Obstructed by Bookcase**

5. Remove all blockages from univents and exhaust ventilators to ensure adequate airflow. Close classroom hallway doors to maximize exhaust ventilation.

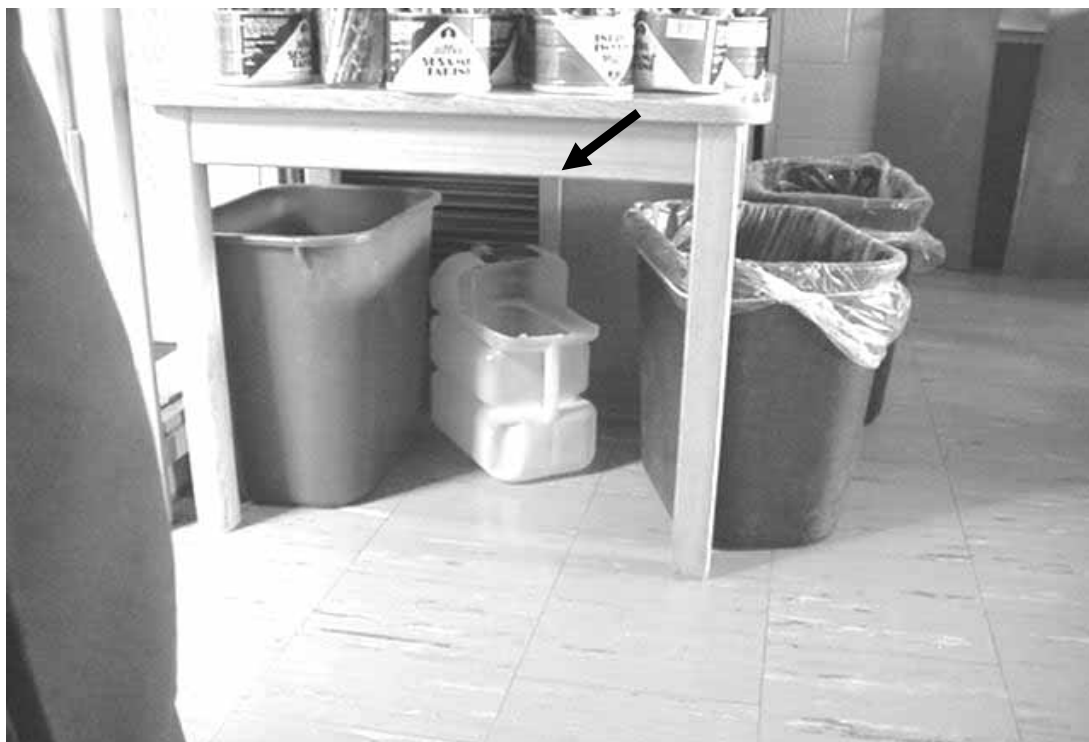
**Picture 4**

**Classroom Exhaust Vent Obstructed with Items**

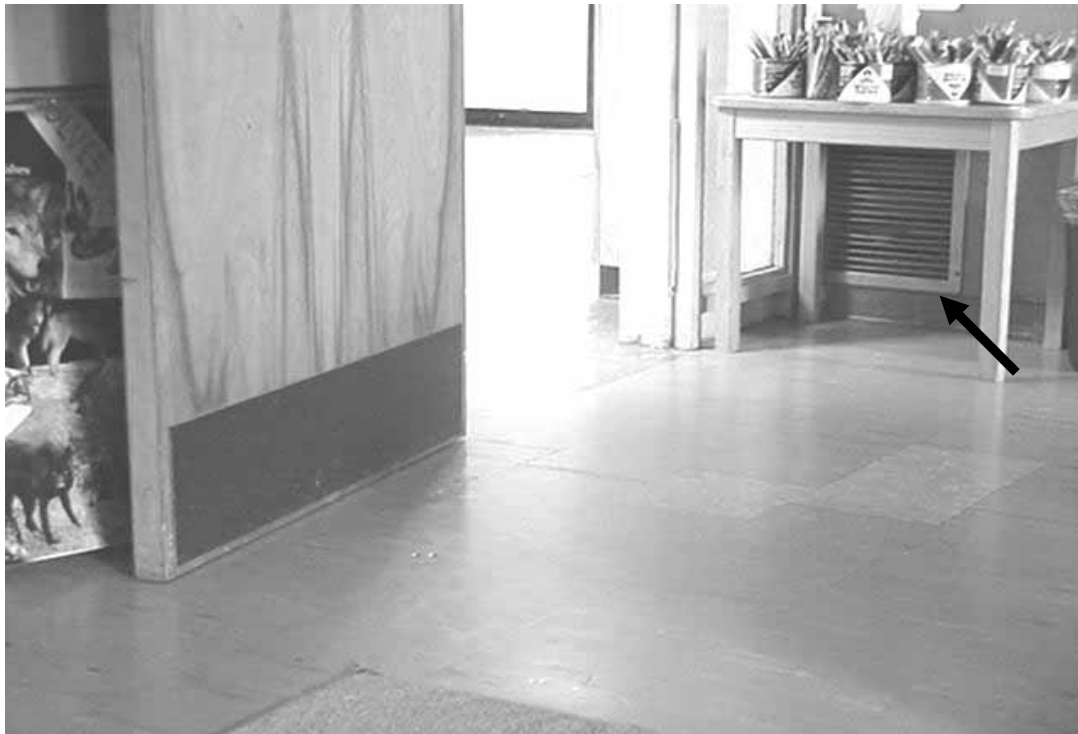
**Picture 5**

**Typical Classroom Configuration of Exhaust Vent and Classroom Door  
Note Door to Hallway is open**

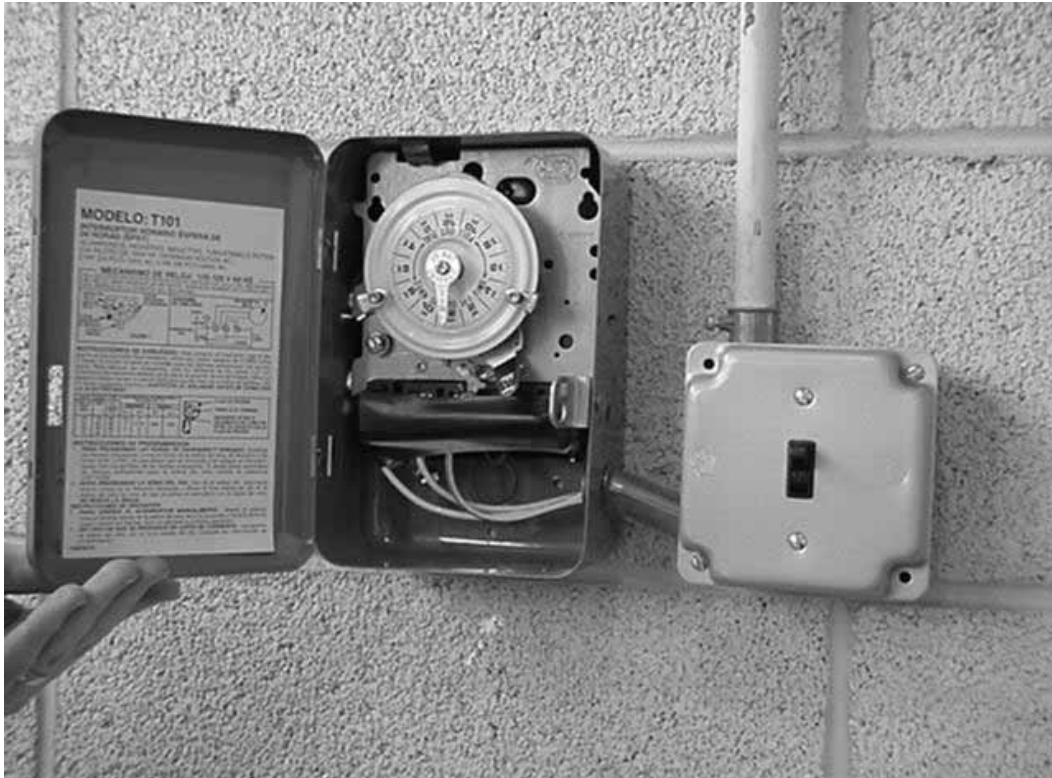
**Picture 6**

Exhaust vents in classrooms 117, 118 and 119 were all noted to be off. These three classrooms share a common exhaust motor, which is controlled by a timer (see Picture 6). Picture 7 shows exhaust vent ductwork that branches off to each classroom respectively. It is possible that this timer may be broken or malfunctioning, which has in turn deactivated the exhaust motor. In classroom 119 the exhaust vent is located on the wall behind the hallway door (see Picture 8). When this door is shut, the vent is clear. In an effort to improve airflow, some teachers will leave the classroom door open, which blocks the exhaust vent, interfering with the proper function of the system.

**Control Timer for Classroom Exhaust Vents (rooms 117-119)**

4. Restore exhaust ventilation in classrooms and office space. Examine rooftop exhaust motors for proper function; repair and replace parts as needed. Examine timer controlling exhaust system in classrooms 117-119 for proper function; repair and recalibrate if necessary.

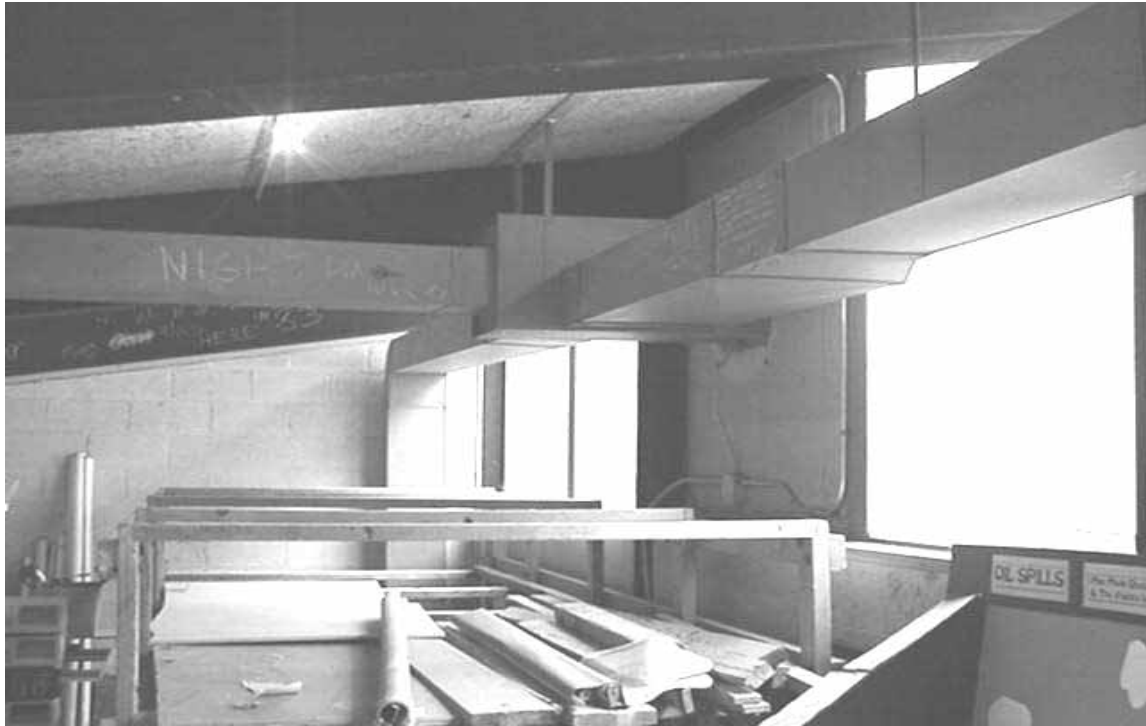
**Picture 7**

**Exhaust Ventilation Ductwork for Classrooms 117-119  
Note Branching Ductwork Connected to Wall-mounted Exhaust Motor**

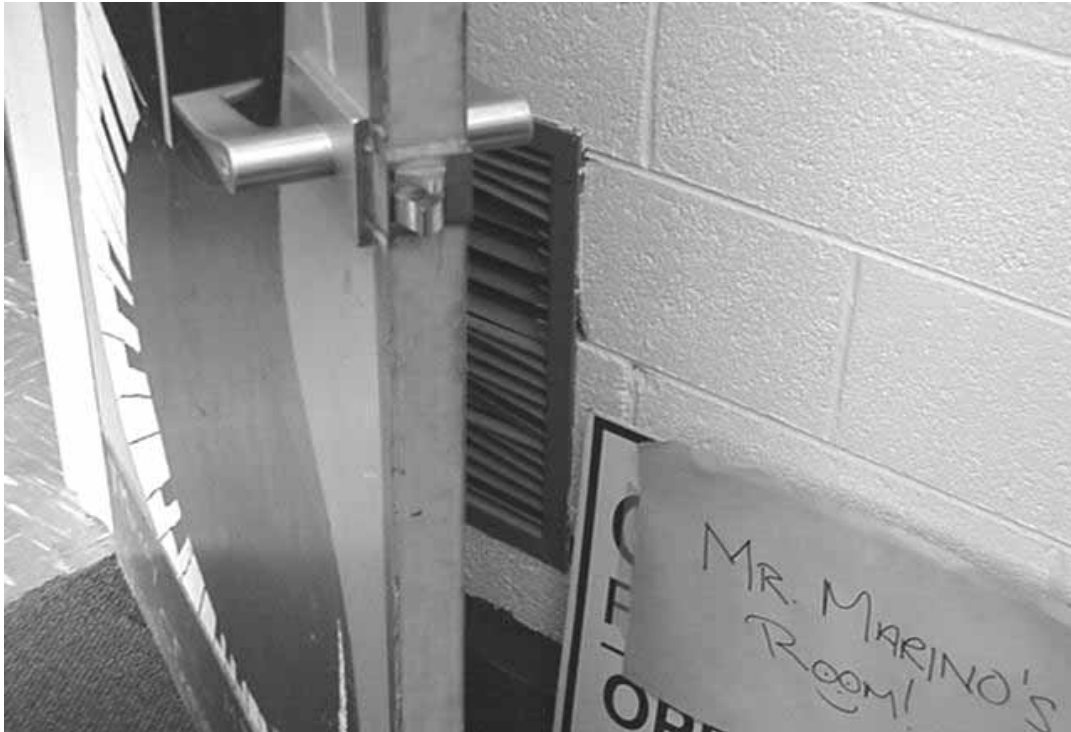
**Picture 8**

**Classroom Exhaust Vent Obstructed by Open Door**

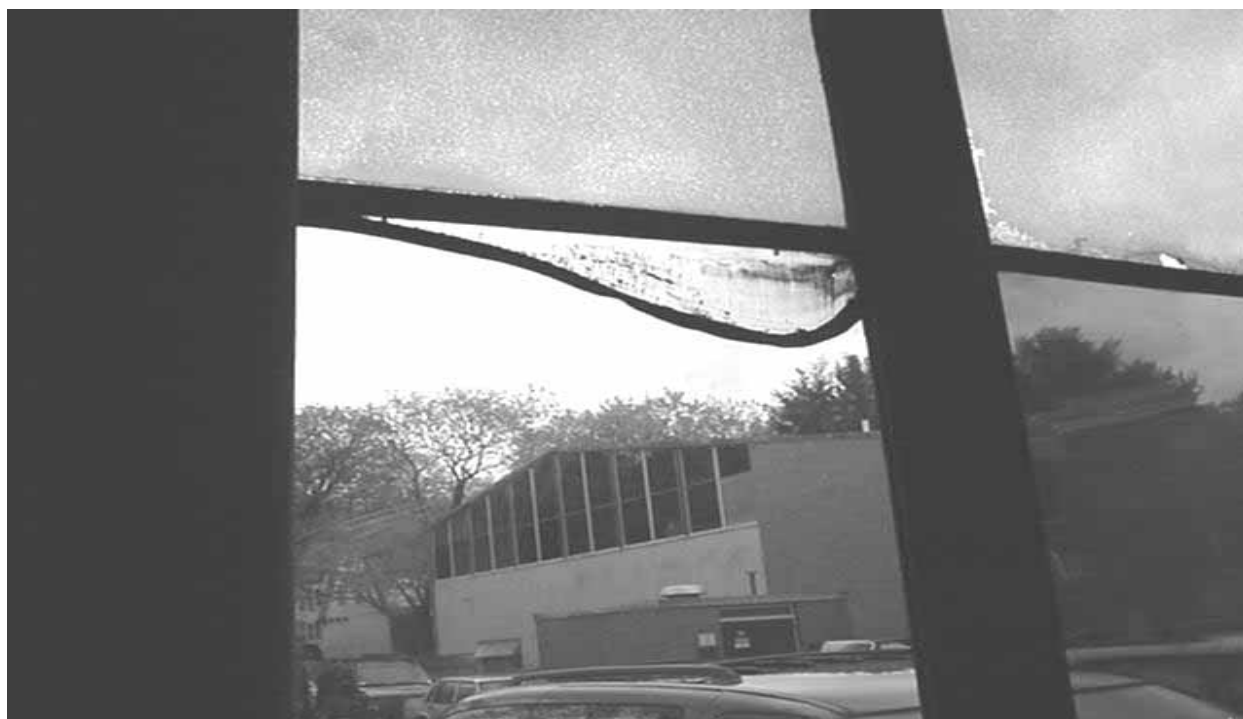
**Picture 9**

Throughout the school, caulking around the interior and exterior windowpanes was crumbling, missing or damaged (see Picture 9). Several rooms contained loose fitting windowpanes and/or cracked or broken windows. Water vapor was observed collecting inside the double-paned window glass (see Picture 10). This indicates that the

**Loose Caulking Noted “Hanging” from Classroom Window**

26. Repair/replace loose/broken windowpanes and missing or damaged window caulking building-wide to prevent water penetration through window frames.

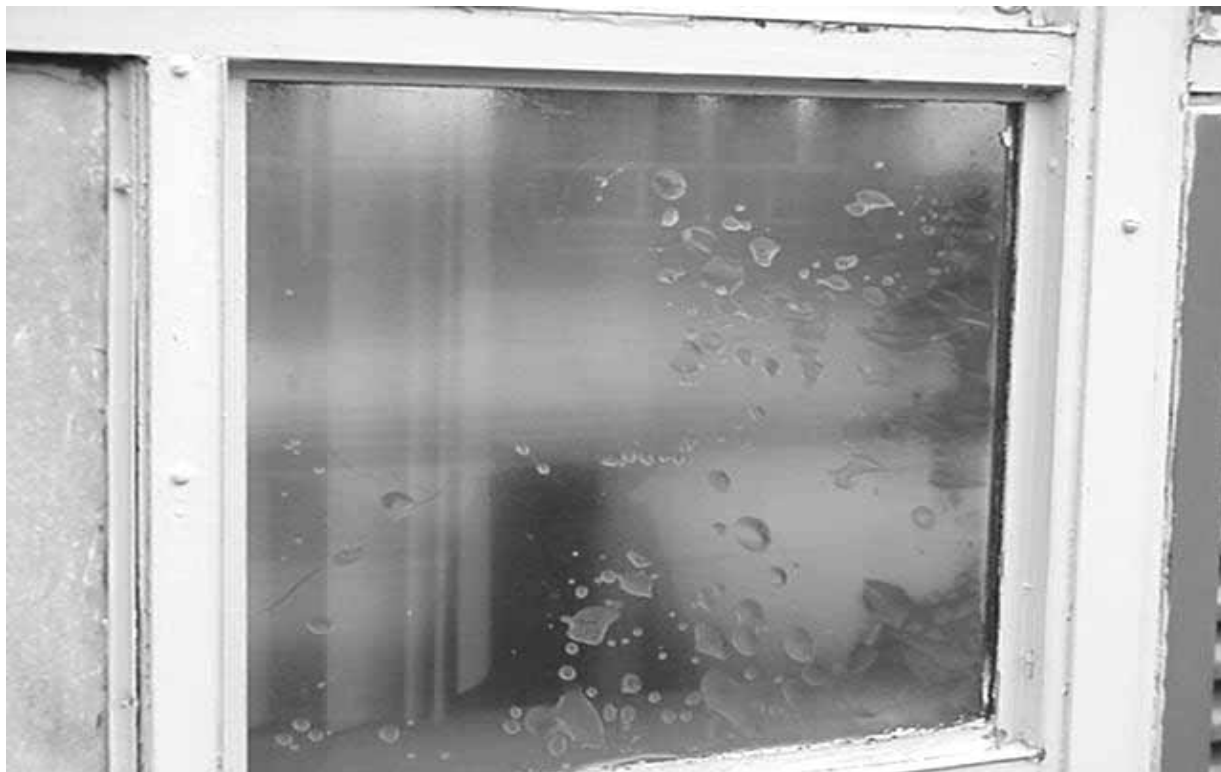
**Picture 10**

window's water seal is no longer intact. Several rooms also contained broken windows (see Tables). Repeated water damage can result in mold colonization of the wooden window frames and porous materials (e.g. curtains). Water damaged curtains are noted in Picture 11. Once mold has colonized, porous materials should be replaced as they are difficult to clean. Repairs of window leaks are necessary to prevent further water penetration. Repeated water damage can result in mold colonization of window frames, curtains and items stored on or near windowsills.

**Water Trapped between Double-Paned Windows Indicating that the Seal is Compromised**

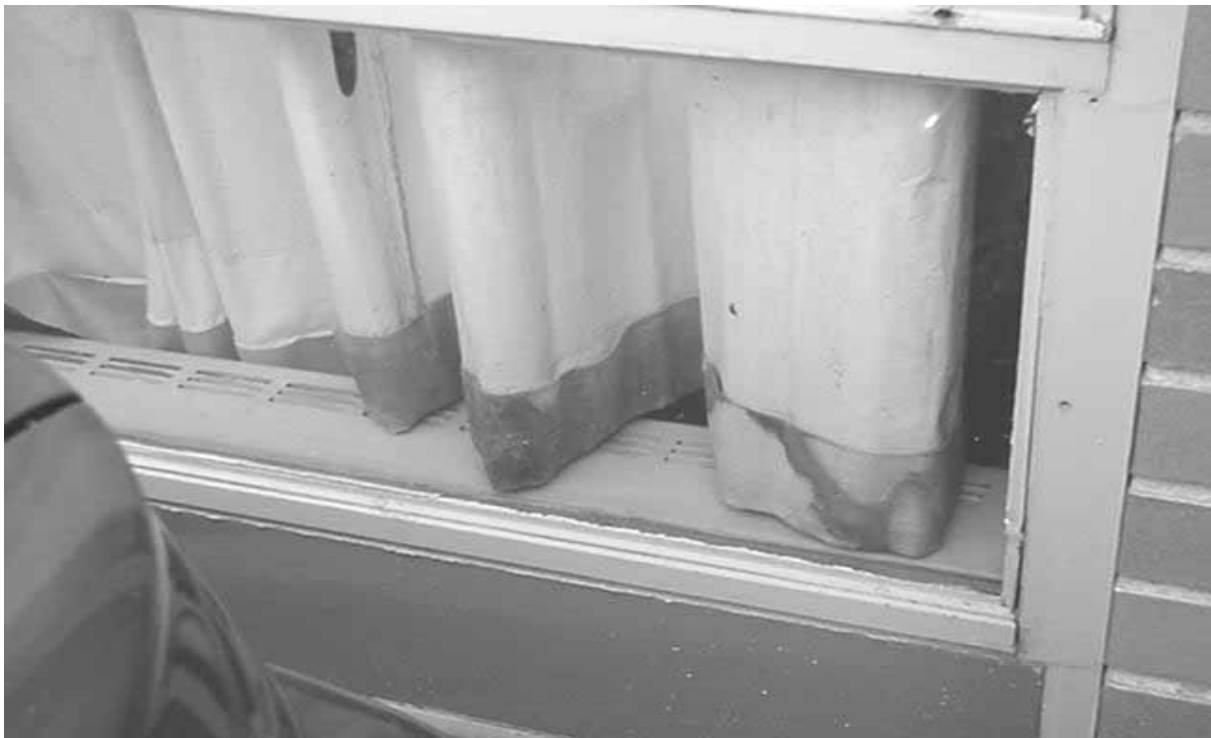
**Picture 11**

**Water-Damaged Curtains Noted in Classroom**

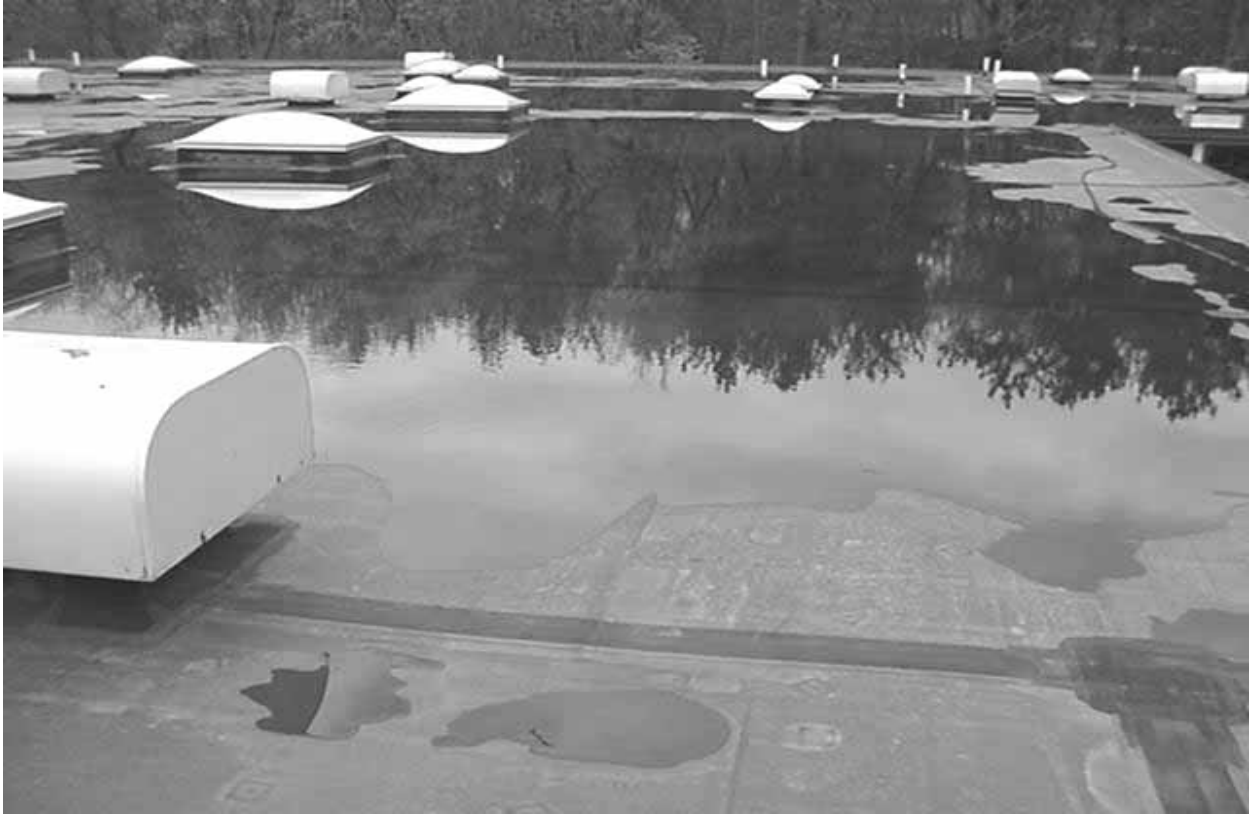
**Picture 12**

Pooling water was observed in a number of areas on the roof (see Picture 12). The freezing and thawing of water during winter months can lead to roof leaks and subsequent water penetration into the interior of the building. Pooling water can also become stagnant, which can lead to mold and bacterial growth, which can be introduced into the building by rooftop fresh air intakes. In addition, stagnant pools of water can serve as a breeding ground for mosquitoes.

**Water Pooling on Roof Note Lack of Drainage in this Area**

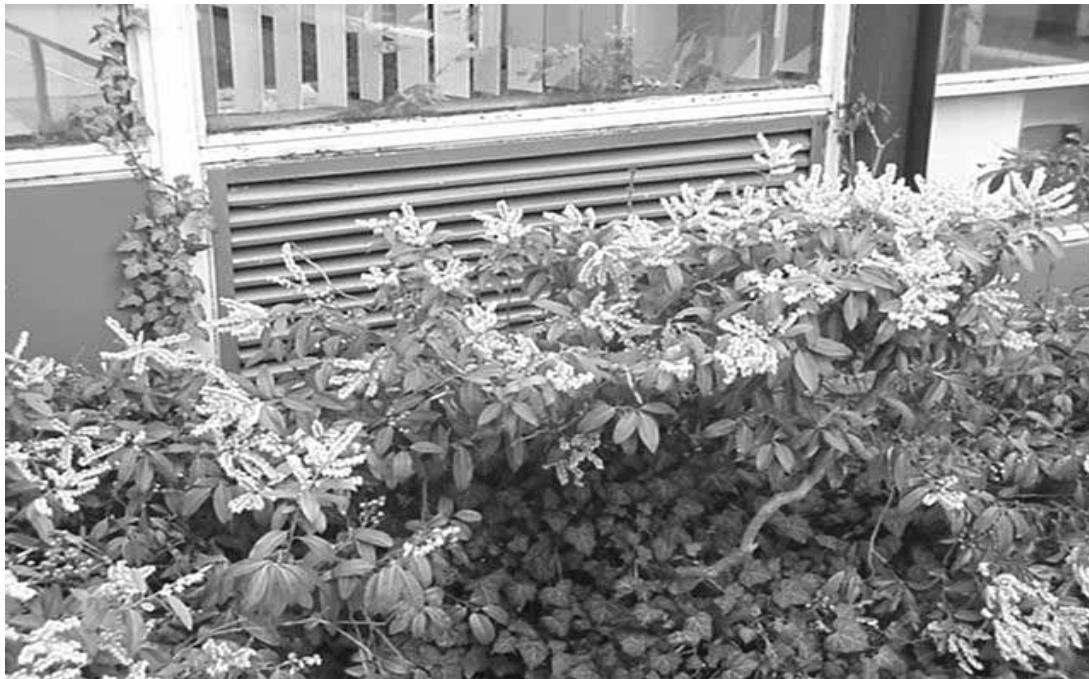
**Picture 13**

Along the perimeter of the building, shrubbery and flowering plants were noted in close proximity to univent fresh air intakes (see Picture 13). Shrubby and flowering plants can be a source of mold and pollen and should be placed and/or maintained to ensure that fresh air intakes remain clear of obstructions to prevent the entrainment of dirt, pollen or mold into the building.

**Univent Fresh Air Intake Obstructed by Shrubbbery**

15. Inspect plant growth outside perimeter of building periodically; trim plants away from fresh air intakes as needed.
16. Refrain from using the pottery kiln until equipment is provided with local exhaust ventilation independent of the general exhaust system.

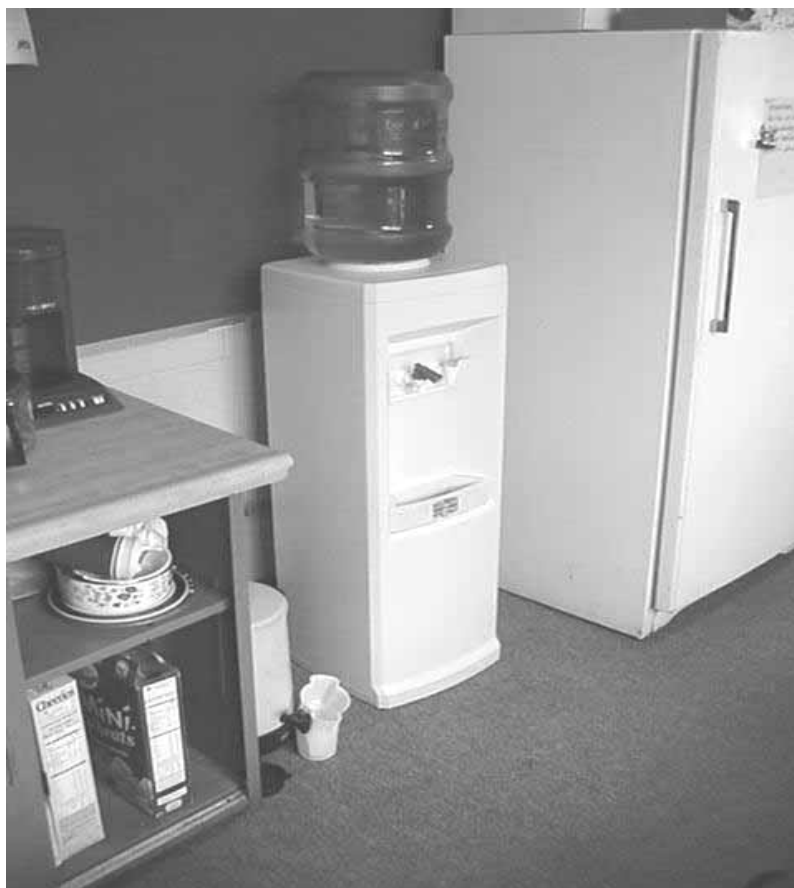
**Picture 14**

The faculty lounge contained a water cooler on a carpeted floor; numerous uncapped, one-gallon plastic water jugs were noted on the carpet (see Pictures 14 & 15). Classroom 119 is a subterranean classroom, at the lowest point of the building. This area is carpeted and was reported to have a history of flooding. The American Conference of Governmental Industrial Hygienists (ACGIH) recommends that carpeting be dried with fans and heating within 24 hours of becoming wet (ACGIH, 1989). If carpets are not dried within this time frame, mold growth may occur. Once mold has colonized porous materials, they are difficult to clean and should be removed.

**Water Cooler Noted on Carpet in Teacher's Lounge**

12. Relocate or place tile or rubber matting underneath water coolers in carpeted areas.
13. Repair/replace broken windowpanes.
14. Install weather-stripping around exterior doors to prevent water intrusion.

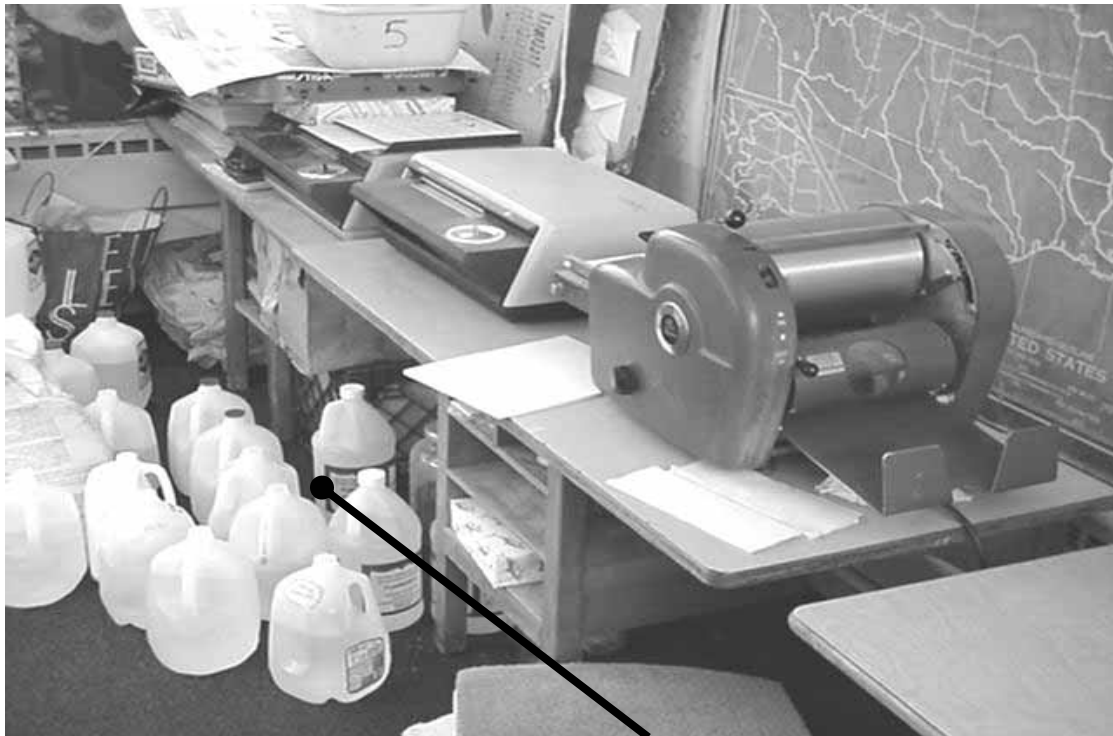
**Picture 15**

**Uncapped One-Gallon Water Jugs Noted on Carpet  
Also Note Flammable Materials and Mimeograph Machine**

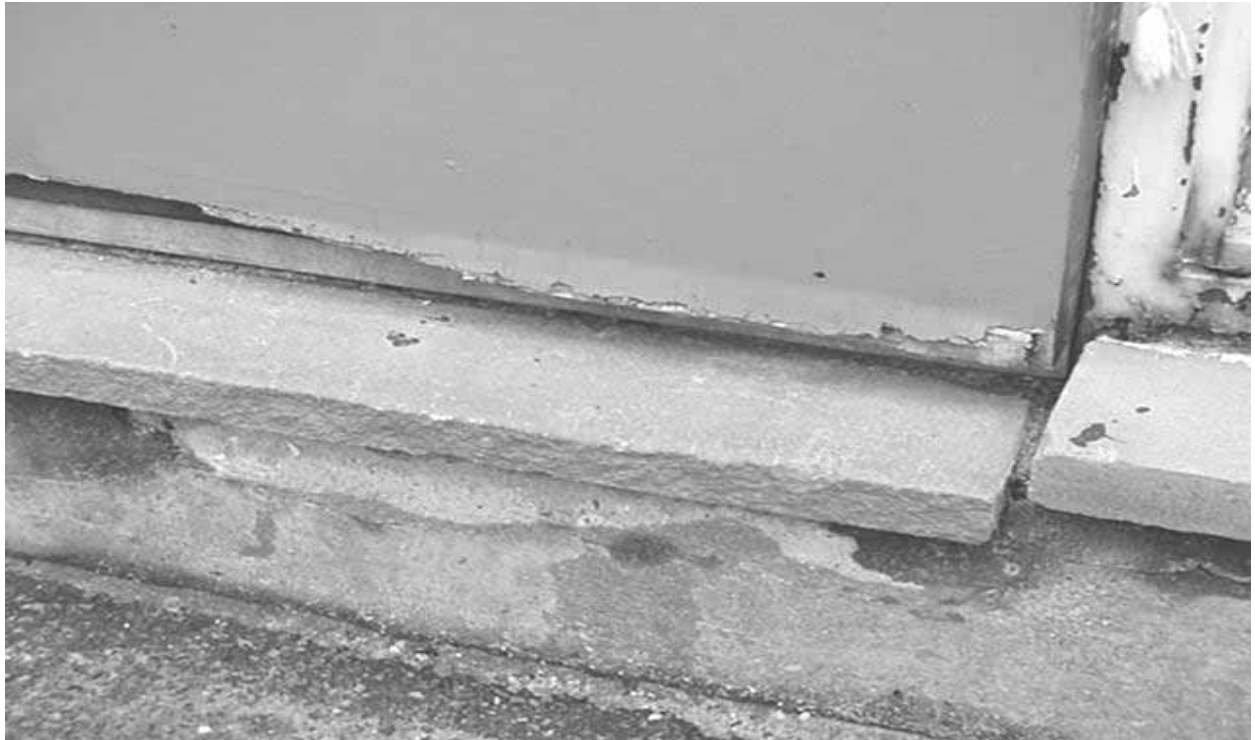
**Picture 16**

Water damage was noted on exterior doors and walls of the building along the foundation and brickwork (see Picture 16). Cracks between the foundation and the exterior wall can result in water penetrating into the building around the vapor barrier. Spaces beneath exterior doors can serve as a source of water entry into the building, causing water damage and potentially leading to mold growth.

**Water-Damaged Exterior Door and Window Frame**

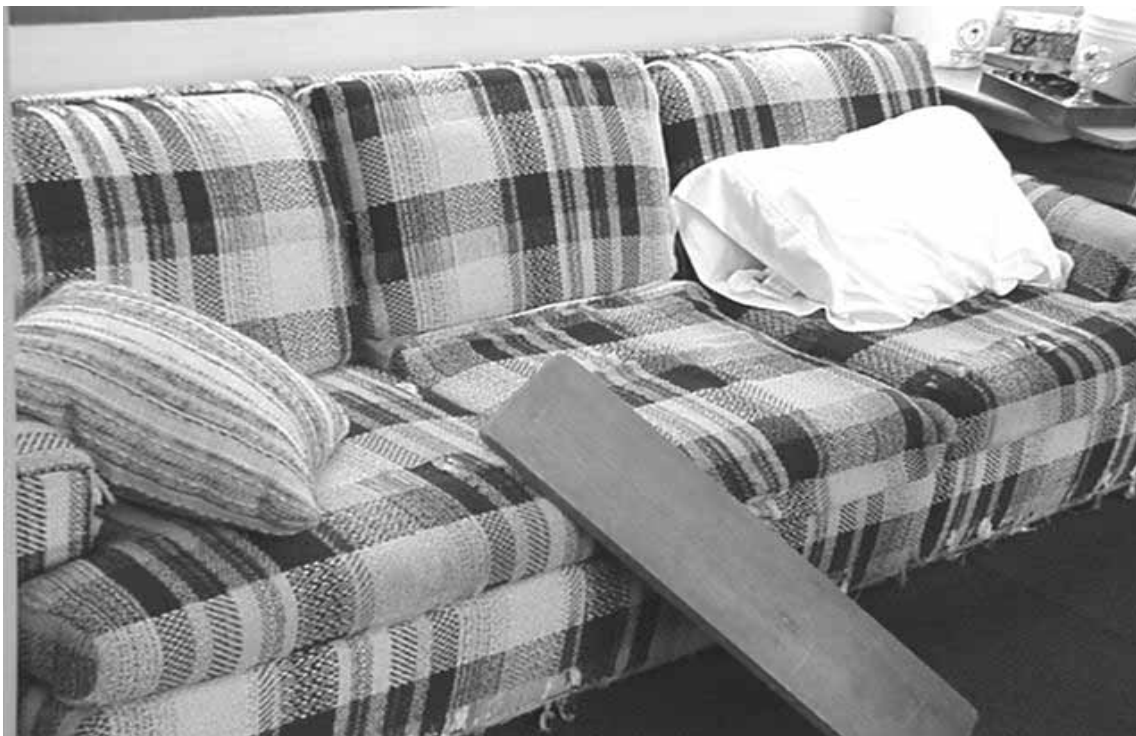
**Picture 17**

Several classrooms have stuffed chairs, sofas and couches (see Picture 17). Many of these appeared to be stained, torn and/or in disrepair. Classroom 119 contained a couch, which had a musty odor. If old furniture and cushions become wet, they can provide a medium for mold growth, which is difficult to clean. In addition, old furniture and cushions can provide a reservoir for dusts and odors to accumulate.

**Furniture Noted in Classroom 119 Note Tears in Upholstery along Base and Cushions**

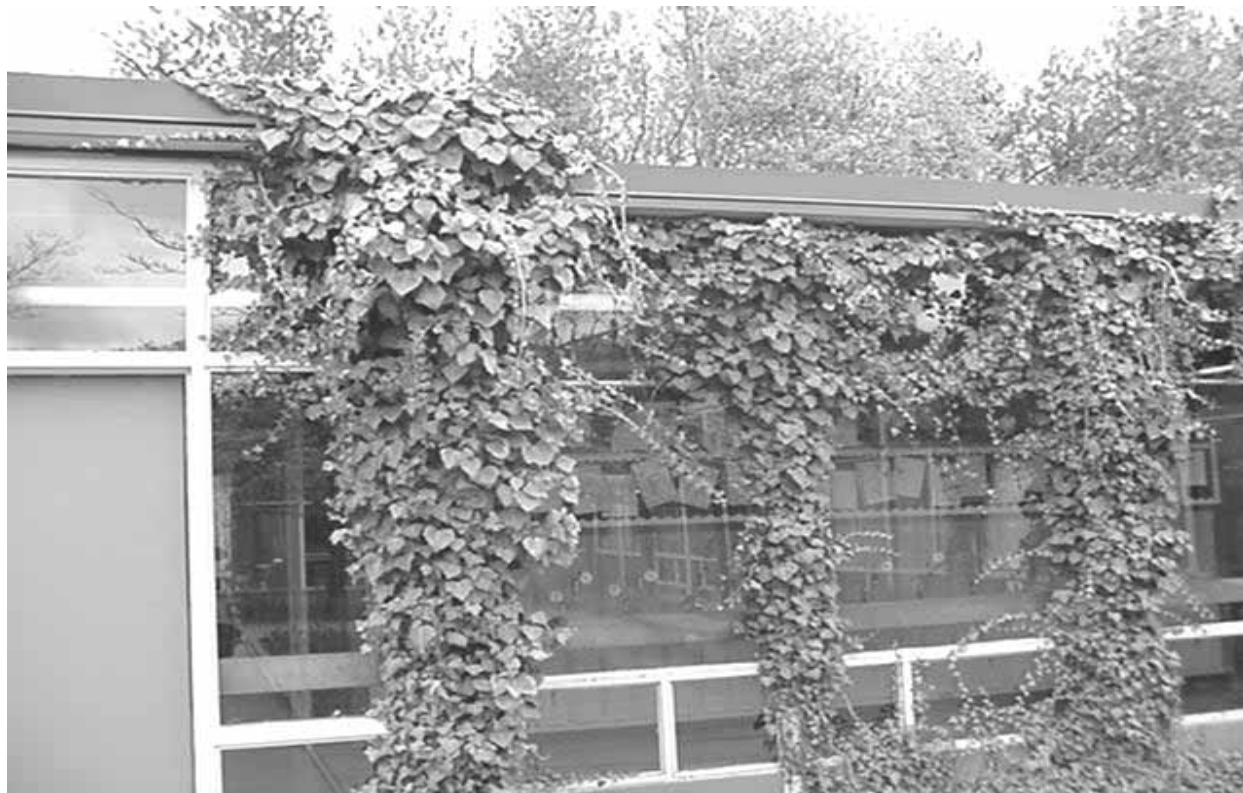
**Picture 18**

The courtyard walls of the school are covered with ivy (see Picture 18). Clinging plants can cause water damage to brickwork by inserting tendrils into brick and mortar. Water can penetrate into the brick along the tendrils, which can subsequently freeze and thaw during the winter. This freezing/thawing action can weaken bricks and mortar, resulting in damage to this wall. In order to avoid this problem, clinging plants on brickwork is not recommended.

**Ivy Growth Noted on Exterior Wall of Courtyard**

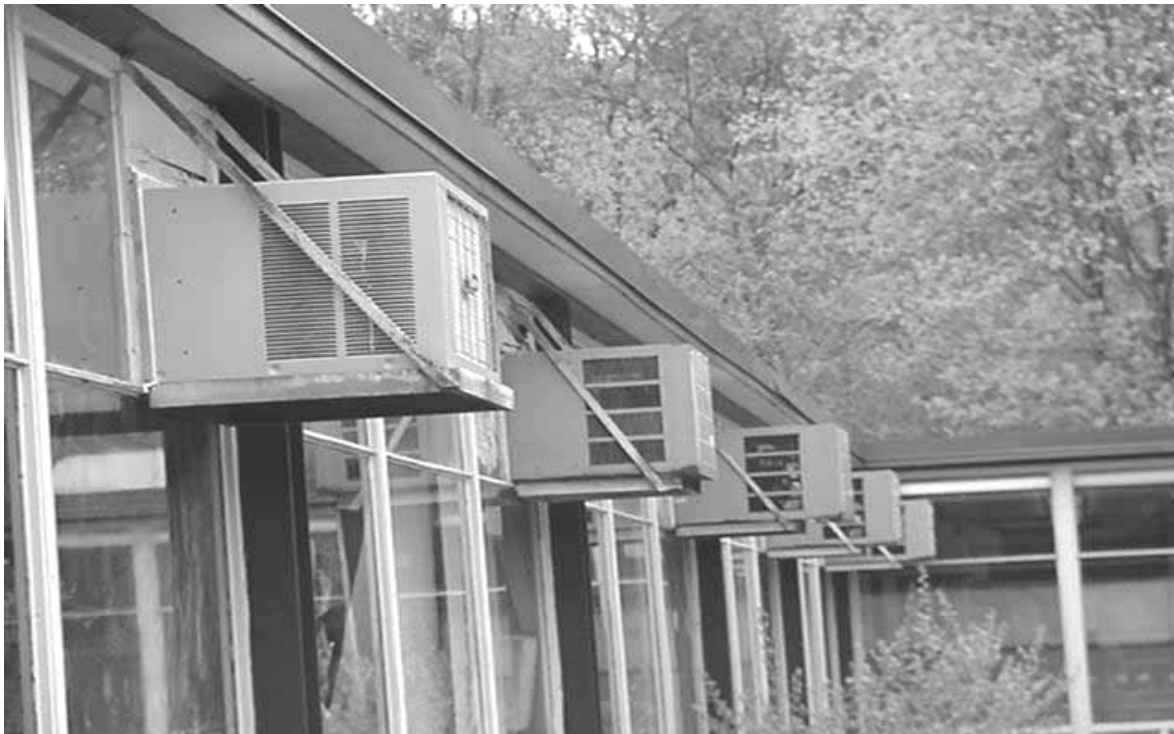
**Picture 19**

A number of areas had window-mounted air conditioning units. In several cases (i.e., the music room and pre-school classroom 7) spaces were observed around air-conditioning units, which provide a means of water penetration into the building. Musty odors were reported in classroom 7, which is a carpeted area. Carpeting in this room should be examined and removed if moldy.

**Window-Mounted Air Conditioning Units**

9. Ensure window mounted air conditioners are properly sealed to prevent water penetration and subsequent mold growth. Disinfect areas of water leaks with an appropriate antimicrobial as needed.

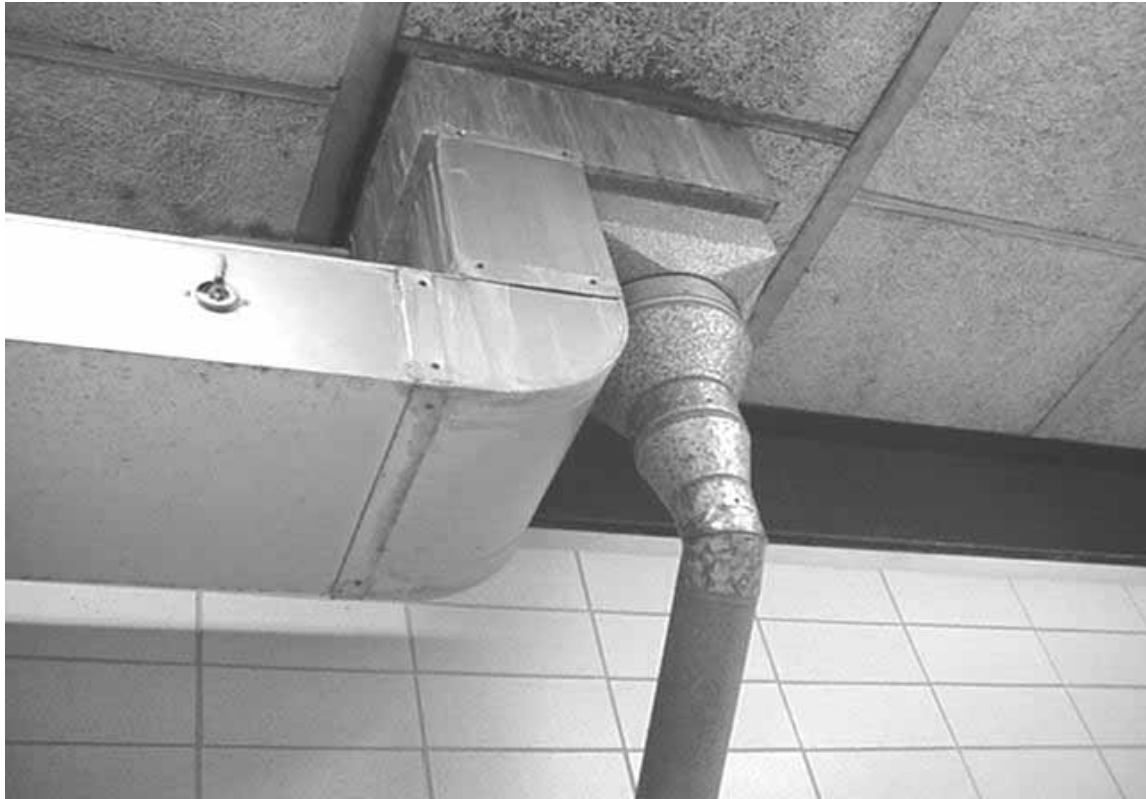
**Picture 20**

Several other conditions were noted during the assessment, which can affect indoor air quality. The art room (formally the kitchen area) contains a kiln equipped with local exhaust ventilation. The exhaust ductwork however appears to be tied in with the general exhaust for the cafeteria (see Picture 20). Pottery kilns can produce carbon monoxide and sulfur dioxide, which can cause respiratory symptoms in exposed individuals (McCann, M., 1985). The configuration of the kiln exhaust presents the opportunity for kiln emissions to enter occupied areas if the general exhaust is not activated. The kiln should be vented directly outside, not connected to the general exhaust.

**Local Exhaust Ventilation for Kiln in Art Room, Ductwork Tied into the General Exhaust Ventilation for the Cafeteria**

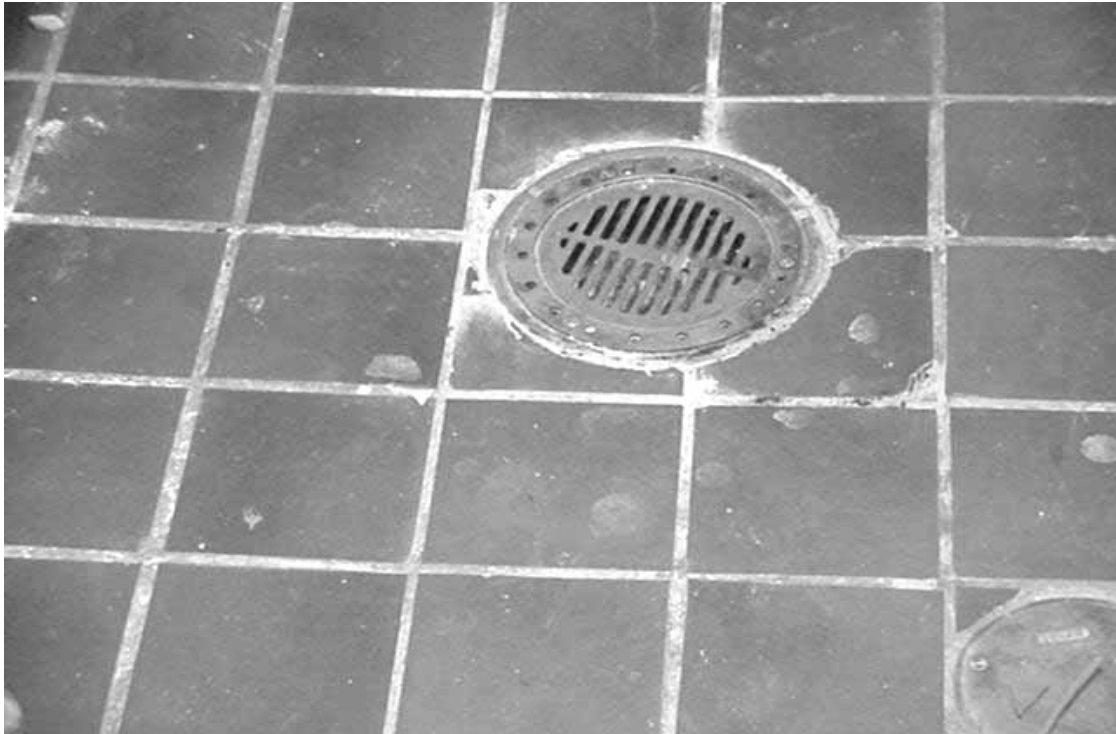
**Picture 21**

The art room also contains a floor drain. Drain traps can dry out if not in use, allowing sewer gas to back up into occupied areas. Sewer gas can create nuisance odors and be irritating to certain individuals. This drain should be capped or wet regularly to prevent sewer gas back up.

**Floor Drain Noted in Art Room**

19. Seal drains in art room or pour water down regularly to prevent sewer gas back up.

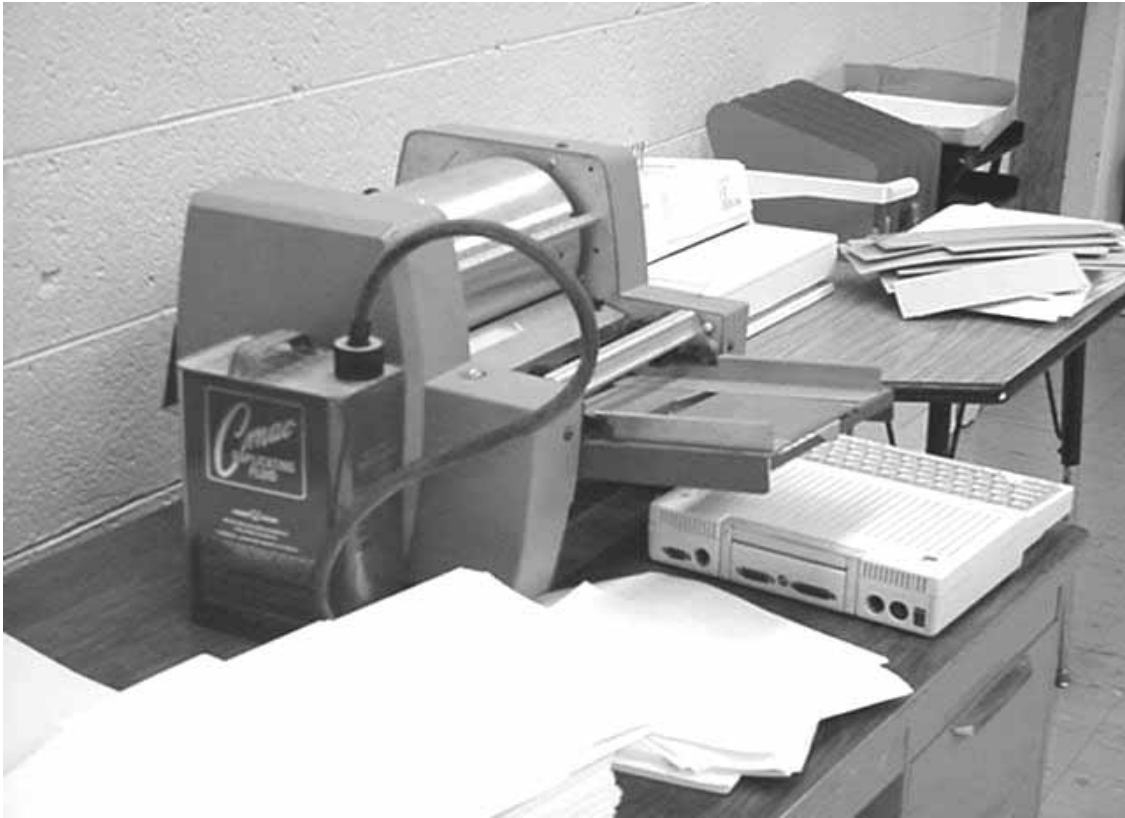
**Picture 22**

**Mimeograph Machine and Duplicating Fluid (Note Duplicating Fluid is a Flammable Material)**

20. Consider relocating photocopiers to a well-ventilated area or examine the feasibility of installing local exhaust ventilation.
21. Consider reducing or discontinuing use of mimeograph machines.

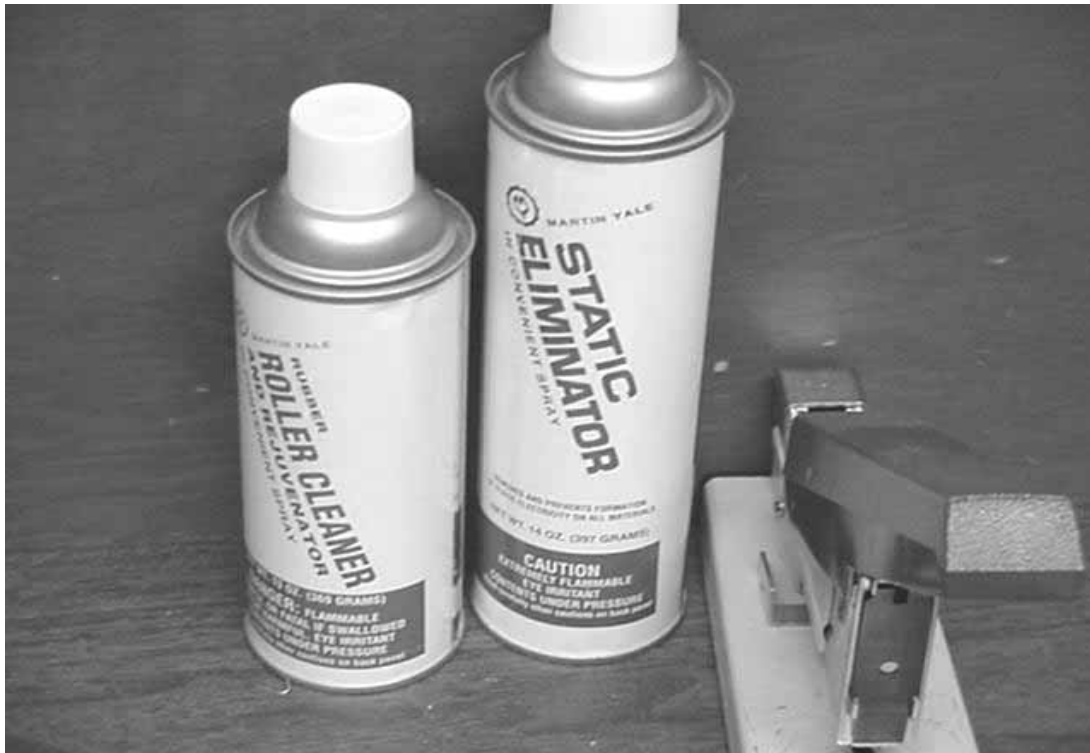
Picture 23

Flammable materials were also noted on the tabletop in the mailroom (see Picture 23). This area was open and unoccupied, allowing easy access for students. These materials should be stored properly and kept out of reach of students. In addition, flammable materials should be stored in a flameproof cabinet that meets the specifications of the National Fire Protection Association (NFPA, 1996).

**Flammable Materials Noted on Tabletop in Mailroom Note Room was  
Open and Unoccupied at the Time**

24. Consider obtaining flameproof cabinets that meet NFPA requirements. Store flammable materials in the flameproof cabinets in a manner consistent with state and local fire codes.
